ON-SITE AIR BAG INVESTIGATION

CASE NO. - 93-07

The 1990 Dodge Daytona was equipped with a driver supplemental restraint system (air bag) which did not deploy as a result of the right front impact. The driver of the vehicle (28 year-old female) was not wearing the available, active, three-point, lap and shoulder belt. The driver was ejected out the backlight and was found just west of the Daytona's final rest position. She sustained fatal injuries including multiple lower left rib fractures and a massive hemothorax (i.e., estimated at between 2000-3000 ccs) which resulted in cardio-pulmonary arrest from exsanguination. The driver of the Daytona was listed on the Police Accident Report as sustaining a "K" (fatal) injury as a result of her crash. The driver (33 year-old male) of the Fiero was listed on the Police Accident Report as restrained and sustaining an "A" (incapacitating) injury.

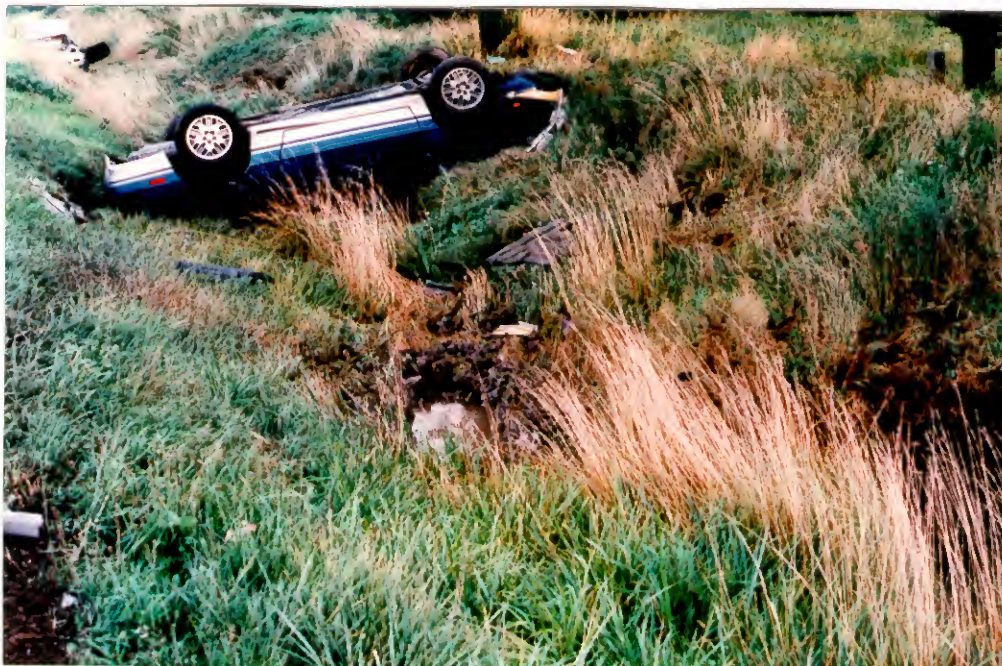
Crash (Cont'd.) dence visible in the on-scene police photographs (see Photographs #02 and #05), the ground divots in the ditch at the scene (see cells E5 and I5 in Photograph #09), and the damage on the case vehicle's right quarter panel indicates that the case vehicle rotated approximately 180 degrees counterclockwise after its initial impact. During the rotation the case vehicle departed the northwest edge of the intersection and impacted the north slope of the ditch with the right rear wheel and quarter panel (see Photograph #30). This impact was of sufficient severity to displace the rear axle to the left and push the right rear wheel inward (see Photograph #11). After impacting the ditch the case vehicle began rotating clockwise and the right front wheel gouged the bottom of the ditch (see cell E5 Photograph #09) loading the right front wheel with mud (see cells D4 and E4 in Photograph #14). The case vehicle rolled over two quarter turns with the right side leading and came to rest facing north on its top in the ditch northwest of the intersection. The evidence in the on-scene police photographs (see Photographs #07 and #21) and the ground divots at the scene indicates that vehicle #2 continued in a northwesterly direction after its initial impact and departed the northwest edge of the intersection. As vehicle #2 traveled along the south slope of the ditch, the left front wheel (see cells A6 and B6 in Photograph #25) dug into the ditch (see cell block F2-I3 in Photograph #14 and cell block A2-I3 in Photograph #15) causing vehicle #2 to rotate approximately 90 degrees counterclockwise and impact the right rear wheel into the north slope of the ditch. Exactly what happened next is not clear; however, the damage on vehicle #2's right quarter panel (see Photographs #20, #22, and #24) and the visible debris (see photograph #07)--including a portion of the windshield (see cell E4 in Photograph #08) and the sun roof (see cells F2 and G2 in Photograph #20), indicates that this impact probably caused vehicle #2 to roll over four quarter turns while continuing to rotate approximately an additional 90 degrees counterclockwise. *(NOTE: the locations of the crash debris is apparently crash related since an interview with rescue personnel revealed that no vehicular components were removed from the car while extracting the driver.)* During the rollover, vehicle #2 impacted a small tree along the north slope of the ditch (see cell H4 in Photograph #08). Vehicle #2 came to rest facing east on its wheels in the ditch northwest of the intersection.

# 09 -- [REDACTED] 1993  
 [REDACTED], Illinois  
 TRC/IU: 93-07, Task: 0103  
 ISP Photo: roadside divot  
 and trip point for Daytona

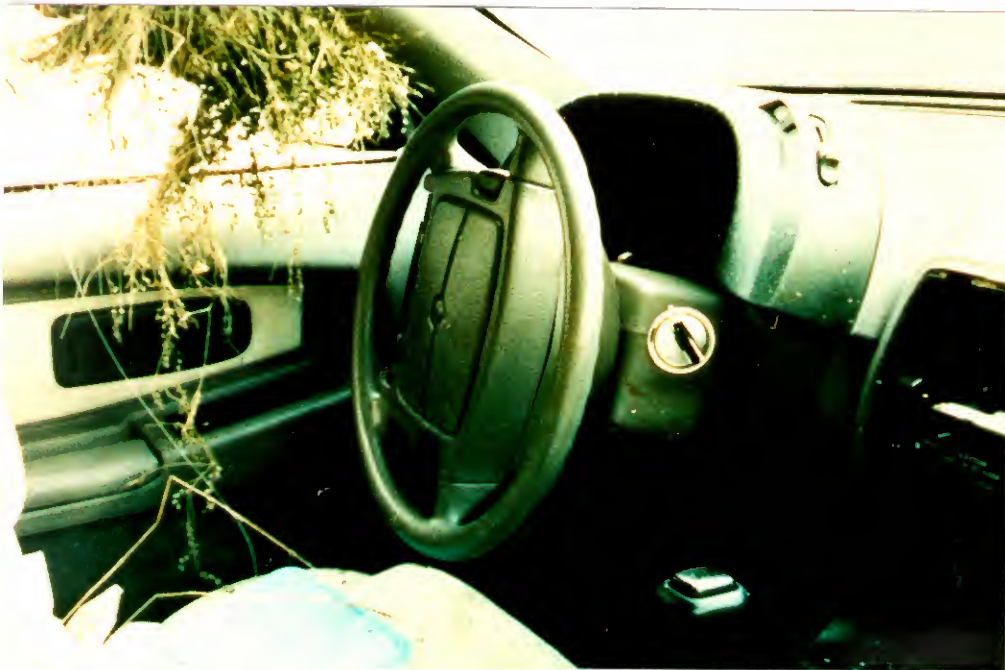
# 18 - [REDACTED] 1993  
 [REDACTED] Illinois  
 TRC/IU: 93-07, Task: 0103  
 ISP Photo: Daytona steering  
 wheel & nondeployed air bag

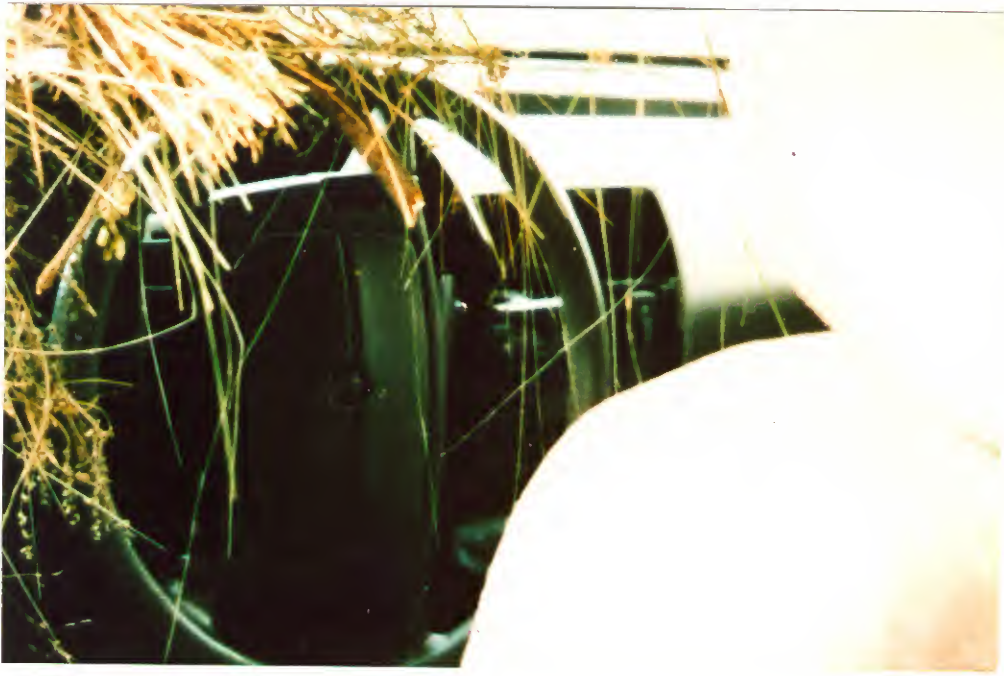
# 19 -- [REDACTED] 1993  
 [REDACTED] Illinois  
 TRC/IU: 93-07, Task: 0103  
 ISP Photo: closeup of air  
 bag cover through LF window

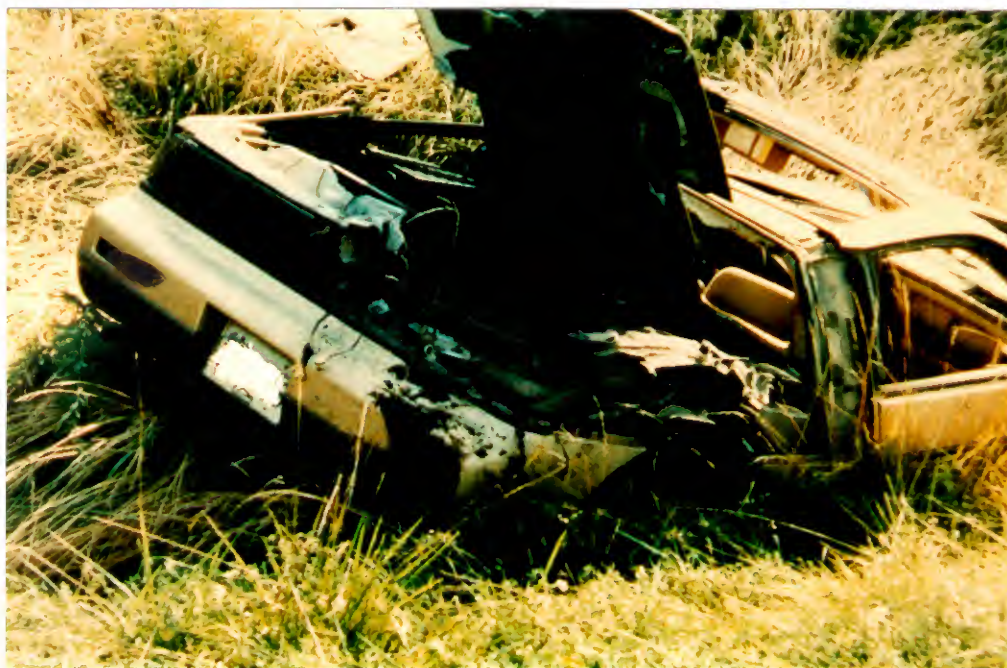
# 22 -- [REDACTED], 1993  
 [REDACTED] Illinois  
 TRC/IU: 93-07, Task: 0103  
 ISP Photo: closeup of Fiero  
 right-rear damage

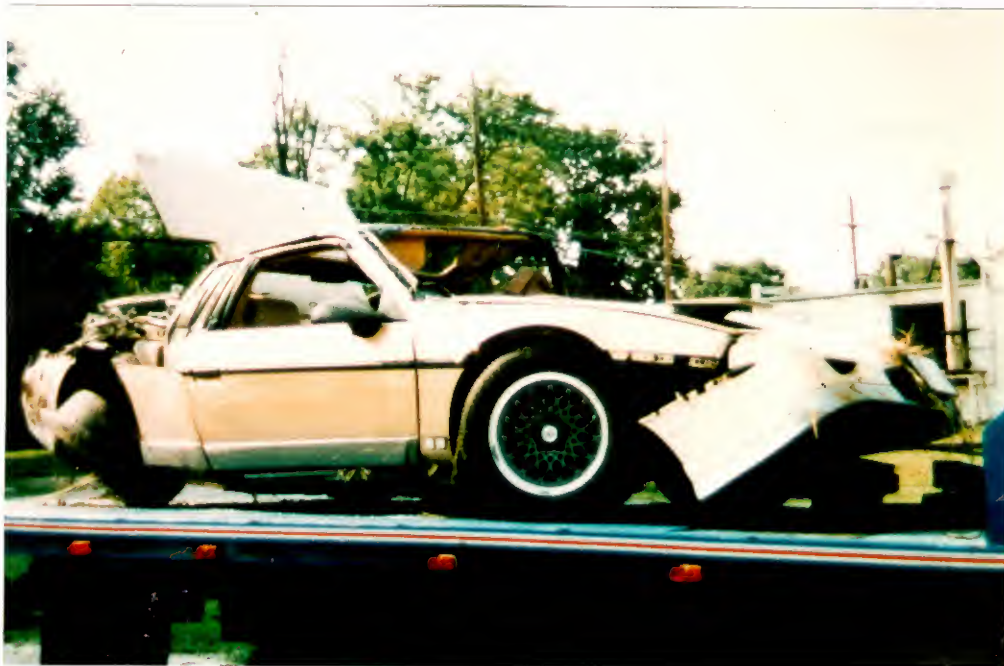
# 24 -- [REDACTED] 1993  
 [REDACTED] Illinois  
 TRC/IU: 93-07, Task: 0103  
 ISP Photo: Fiero's right  
 side damage

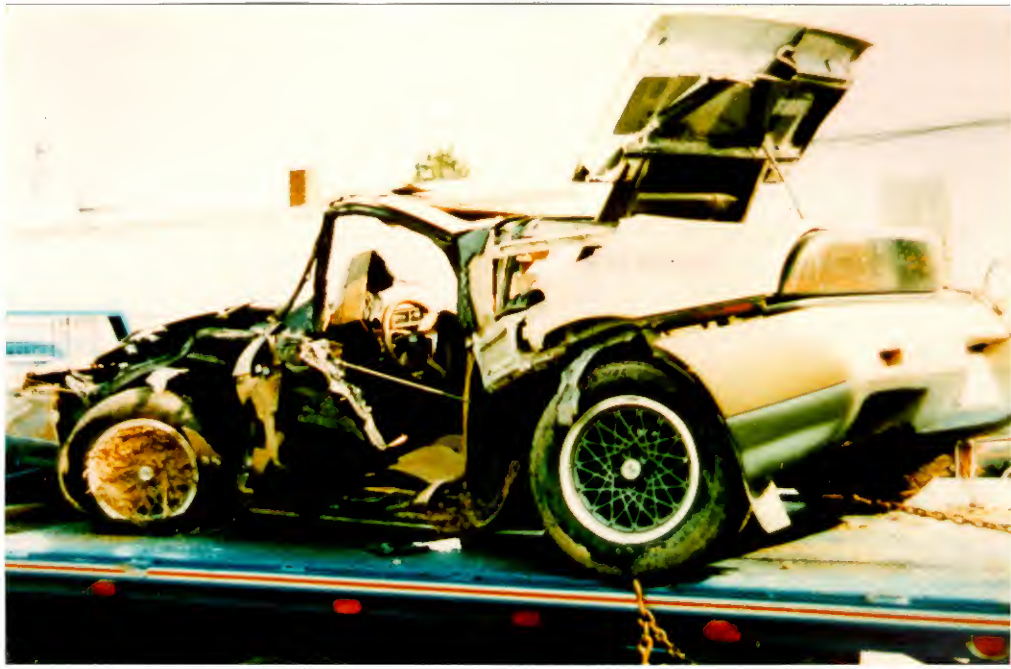
# 25 -- [REDACTED] 1993  
 [REDACTED] Illinois  
 TRC/IU: 93-07, Task: 0103  
 ISP Photo: Fiero's left  
 side damage

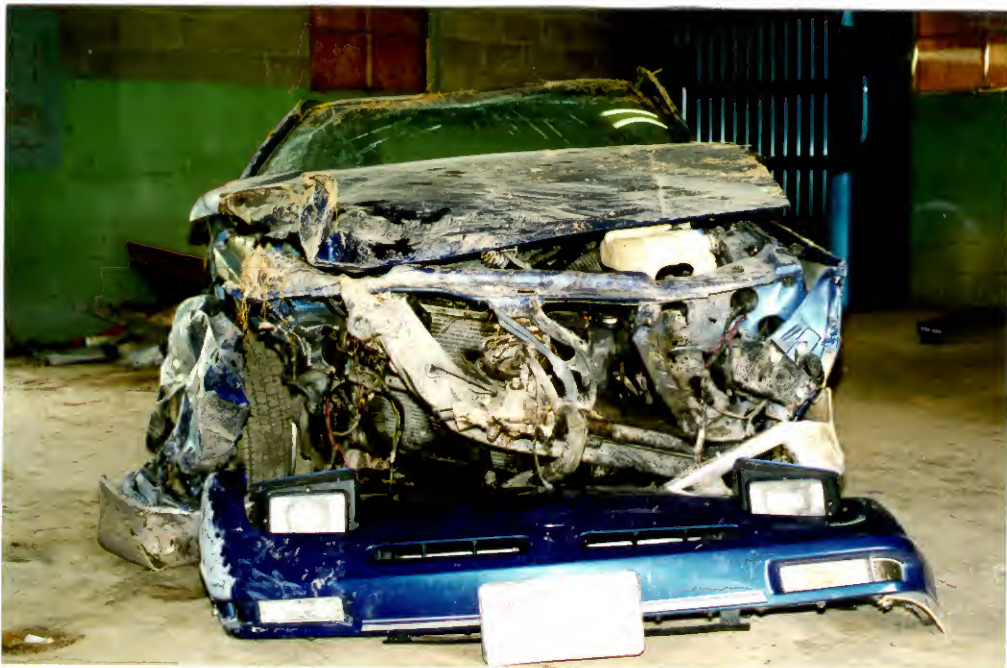
# 26 -- [REDACTED] 1993  
 [REDACTED] Illinois  
 TRC/IU: 93-07, Task: 0103  
 TRC Photo: Dodge Daytona's  
 front damage

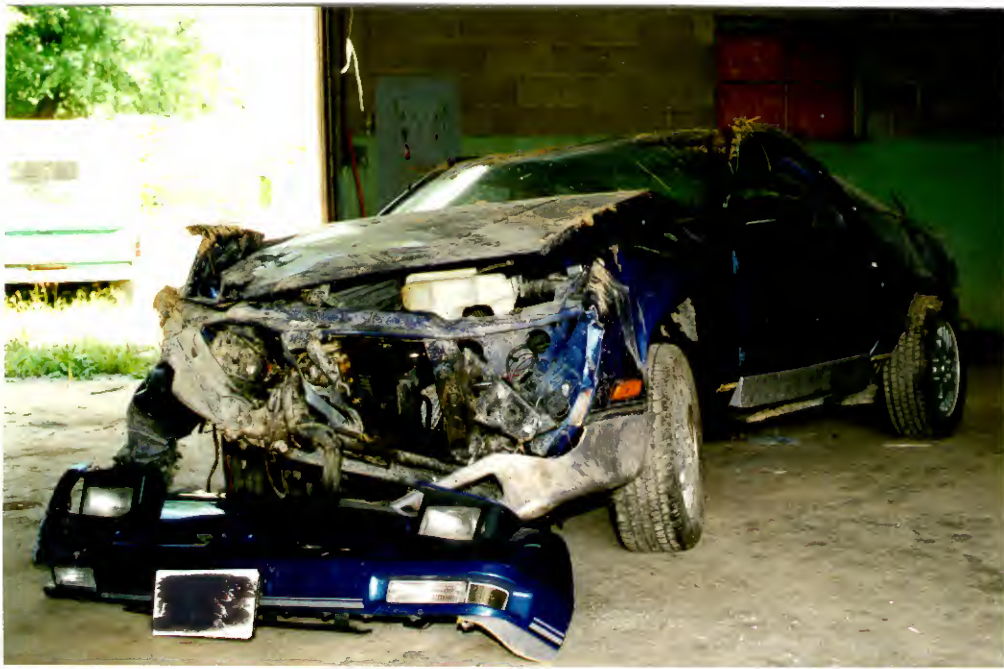
# 27 -- [REDACTED], 1993  
 [REDACTED], Illinois  
 TRC/IU: 93-07, Task: 0103  
 TRC Photo: Daytona's damage  
 from front-left perspective

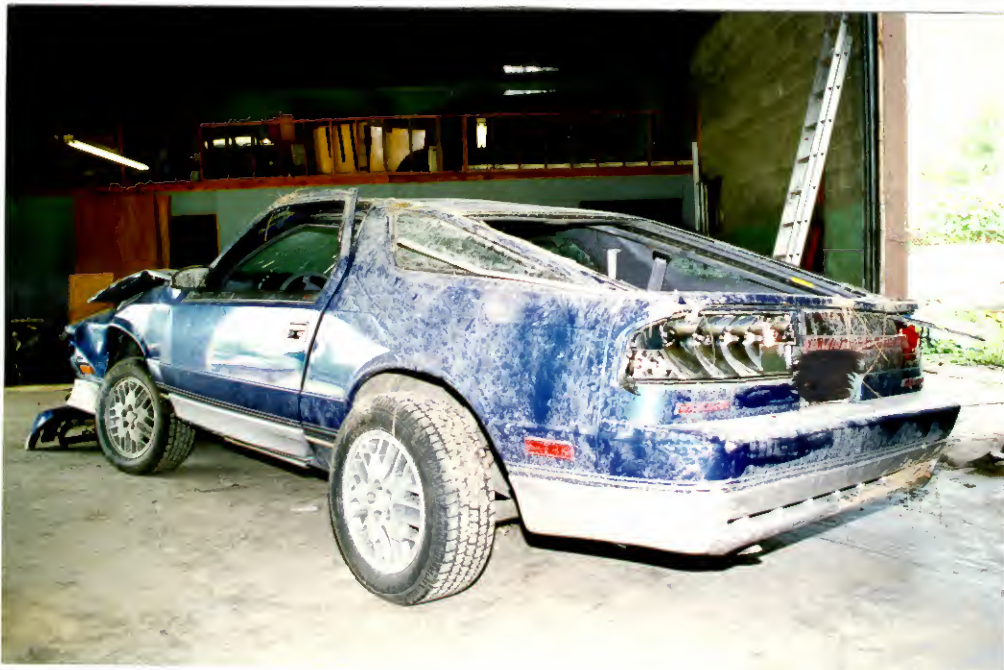
# 28 -- [REDACTED], 1993  
 [REDACTED], Illinois  
 TRC/IU: 93-07, Task: 0103  
 TRC Photo: Daytona's damage  
 from back-left perspective

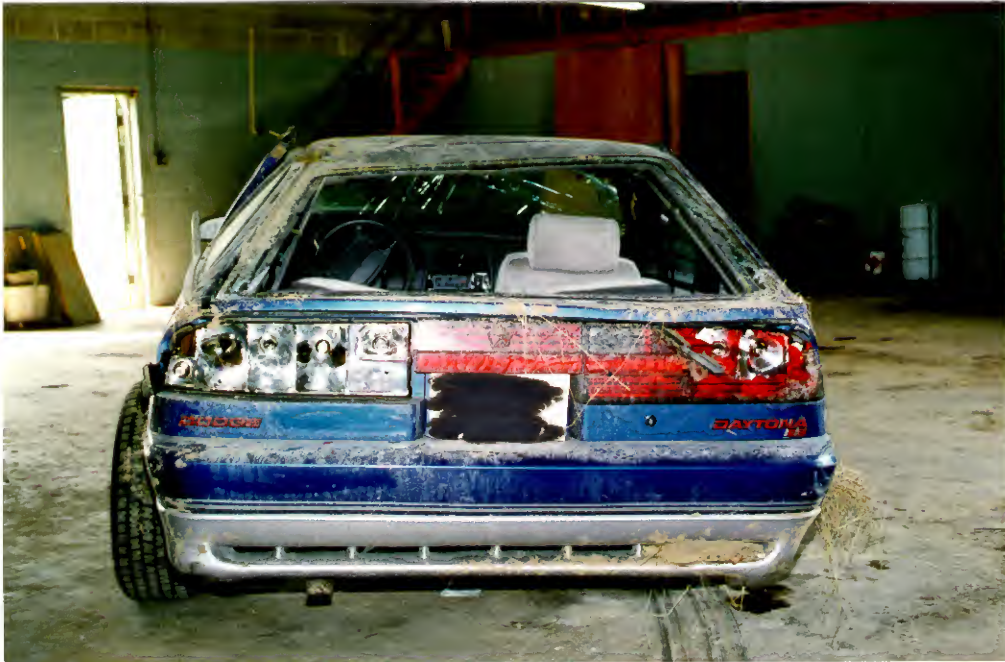
# 29 - [REDACTED] 1993  
[REDACTED], Illinois  
TRC/IU: 93-07, Task: 0103  
TRC Photo: Daytona's back  
damage

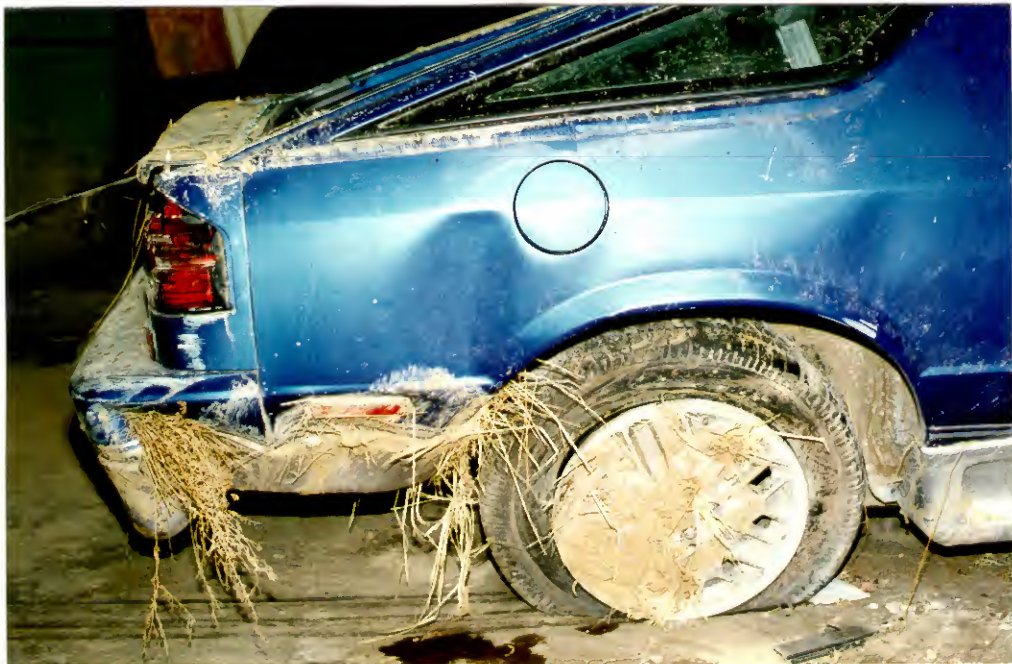
# 30 -- [REDACTED] 1993  
[REDACTED], Illinois  
TRC/IU: 93-07, Task: 0103  
TRC Photo: closeup damage &  
grass at right-rear area

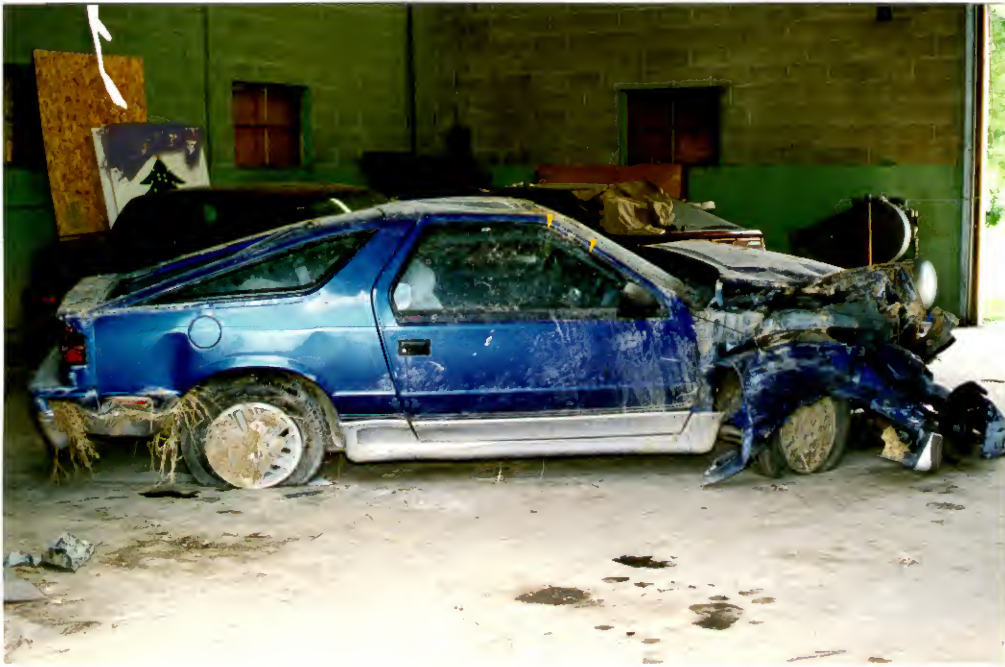
# 31 -- [REDACTED], 1993  
 [REDACTED], Illinois  
 TRC/IU: 93-07, Task: 0103  
 TRC Photo: Daytona's right  
 side damage

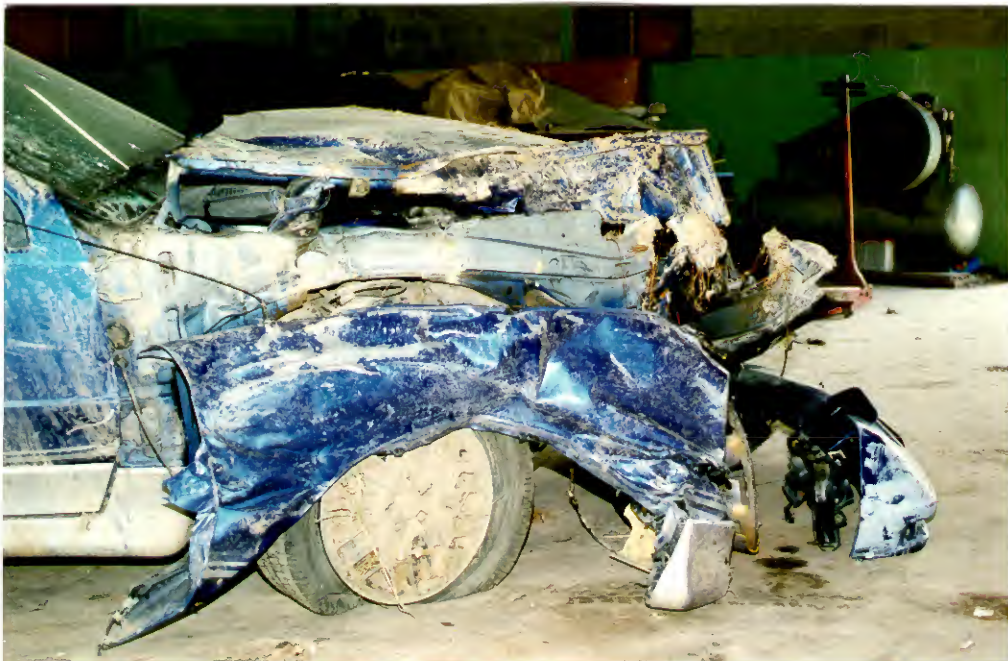
# 32 -- [REDACTED], 1993  
 [REDACTED], Illinois  
 TRC/IU: 93-07, Task: 0103  
 TRC Photo: closeup damage  
 at right-front area

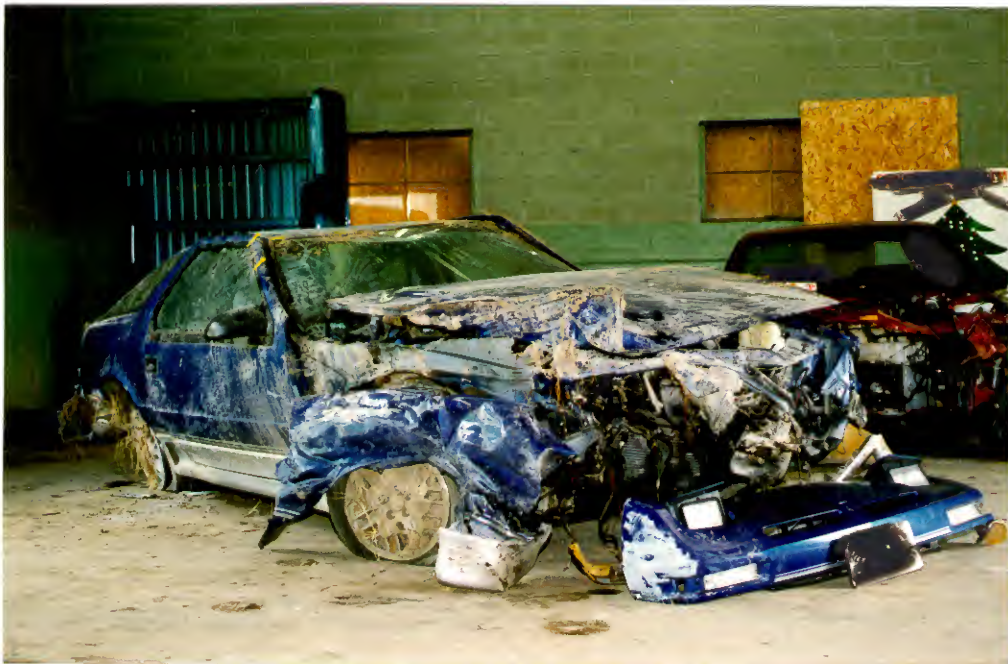
# 33 -- [REDACTED] 1993  
 [REDACTED] Illinois  
 TRC/IU: 93-07, Task: 0103  
 TRC Photo: Daytona's damage  
 from front-right perspective

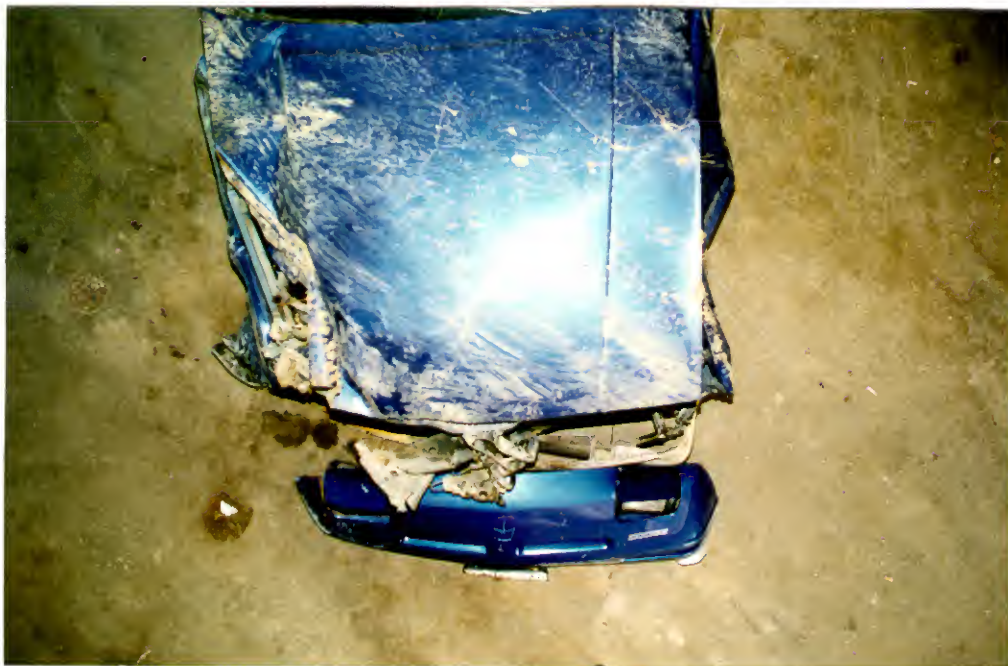
# 34 -- [REDACTED] 1993  
 [REDACTED] Illinois  
 TRC/IU: 93-07, Task: 0103  
 TRC Photo: Daytona's damage  
 from top-front perspective

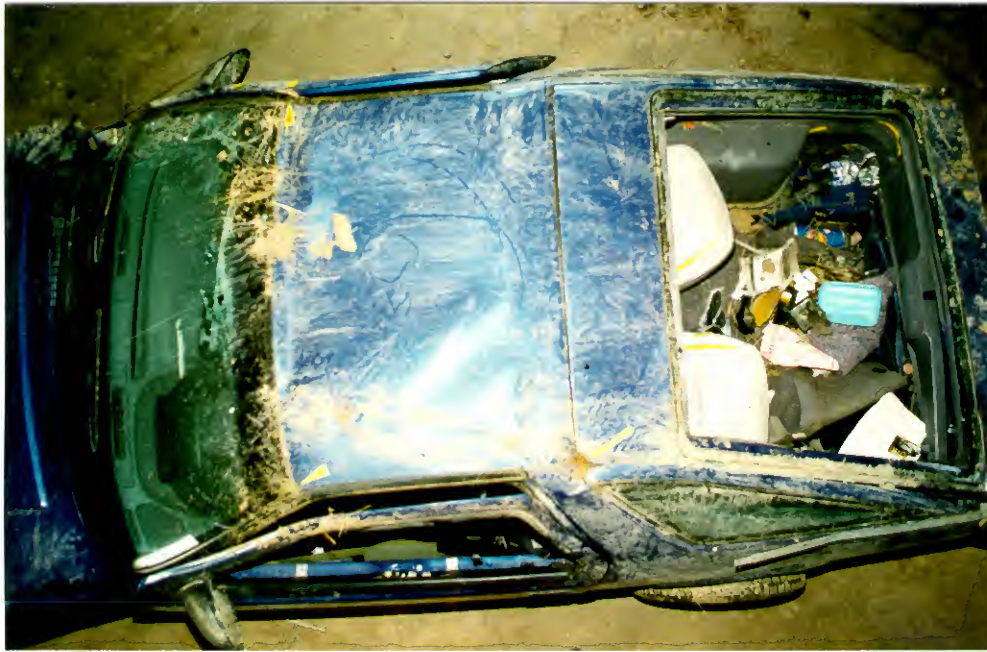
# 37 -- [REDACTED] 1993  
[REDACTED] Illinois  
TRC/IU: 93-07, Task: 0103  
TRC Photo: rollover damage  
from top-left perspective

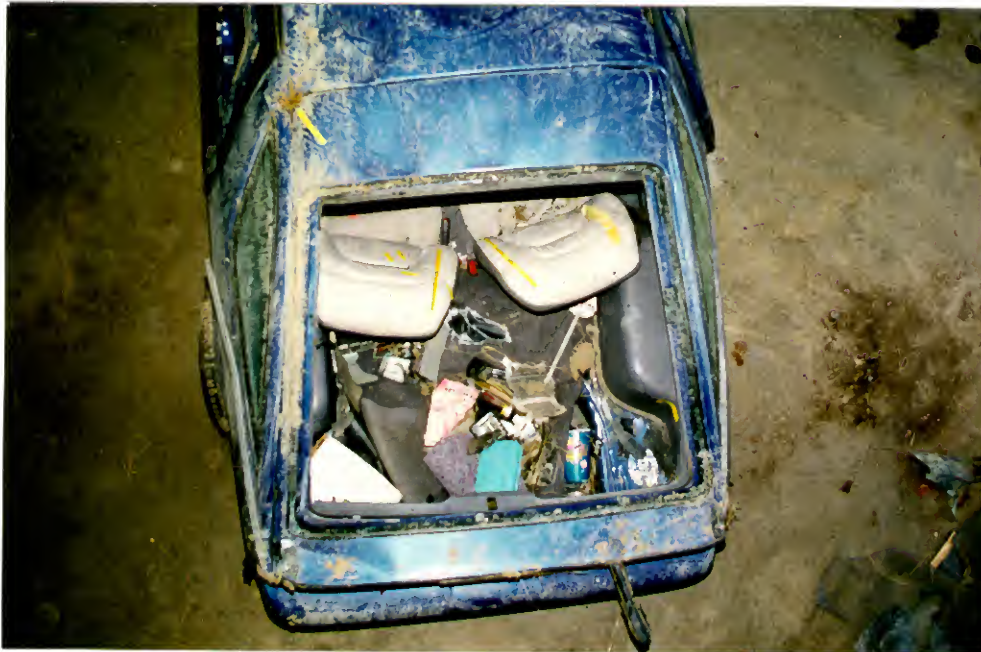
# 38 -- [REDACTED] 1993  
[REDACTED] Illinois  
TRC/IU: 93-07, Task: 0103  
TRC Photo: rollover damage  
& ejection path--top-back

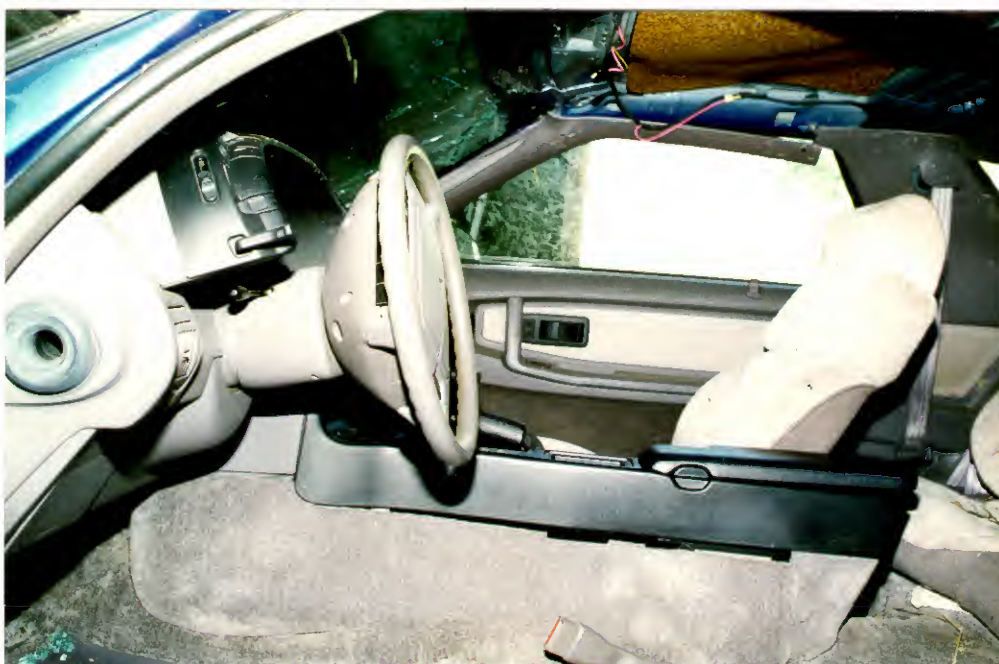
# 42 -- [REDACTED] 1993  
 [REDACTED] Illinois  
 TRC/IU: 93-07, Task: 0103  
 TRC Photo: steering wheel &  
 bag cover-no loading evident

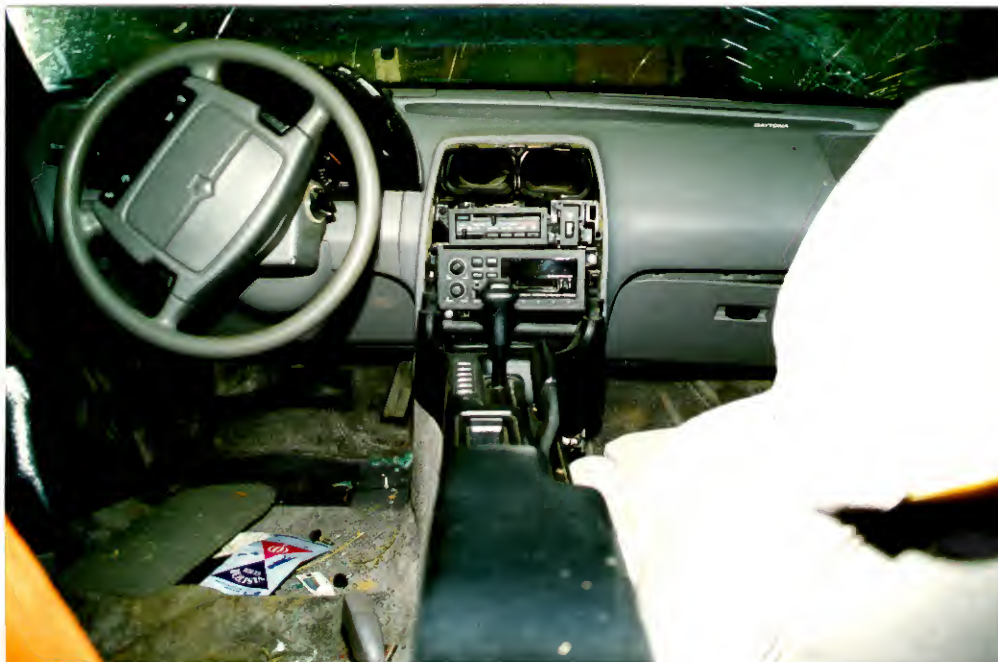
# 45 - [REDACTED] 1993  
[REDACTED], Illinois  
TRC/IU: 93-07, Task: 0103  
TRC Photo: center panel  
with portions missing

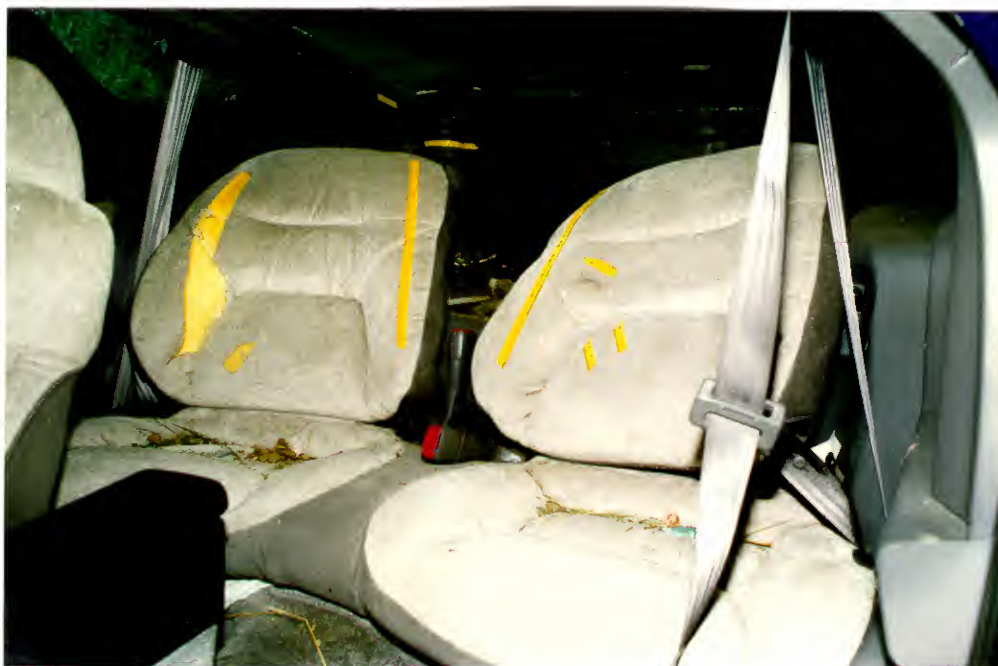
# 48 - [REDACTED] 1993  
[REDACTED], Illinois  
TRC/IU: 93-07, Task: 0103  
TRC Photo: rear seats bent  
by ejection-from driver area

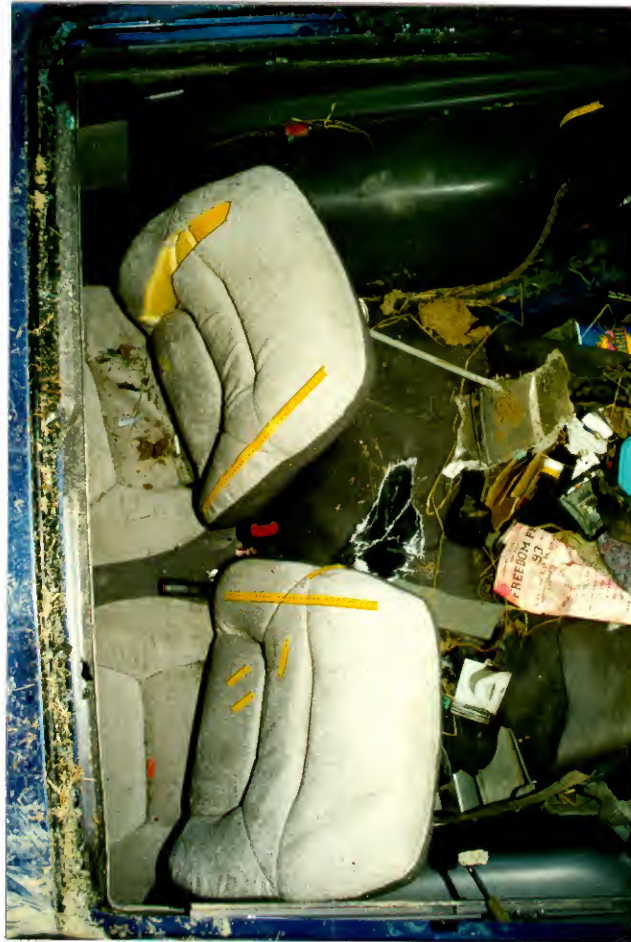
# 49 -- [REDACTED] 1993  
[REDACTED] Illinois  
TRC/IU: 93-07, Task: 0103  
TRC Photo: bent rear seats  
from top through backlight

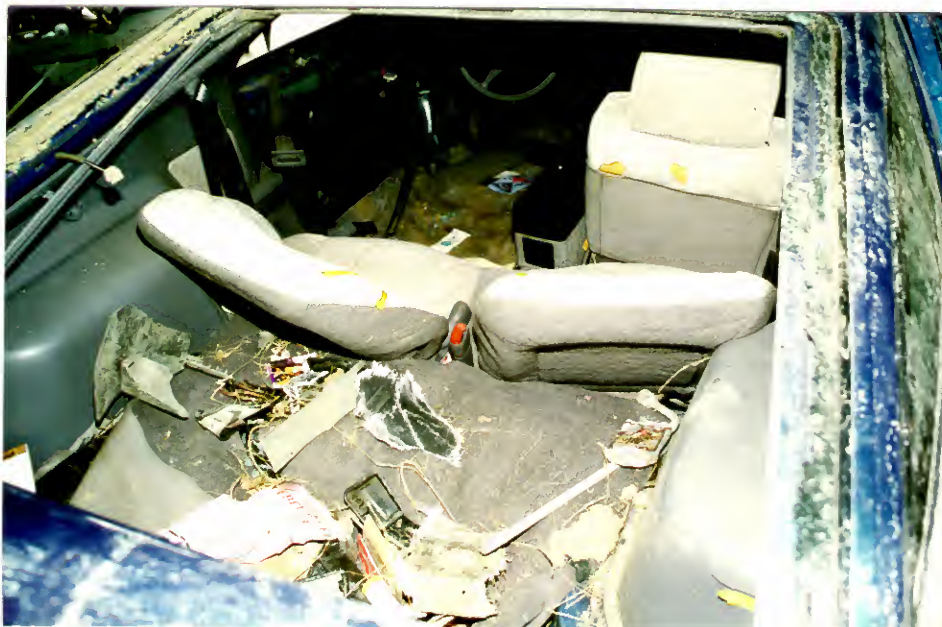
# 50 -- [REDACTED] 1993  
[REDACTED] Illinois  
TRC/IU: 93-07, Task: 0103  
TRC Photo: bent rear seats  
from back through backlight

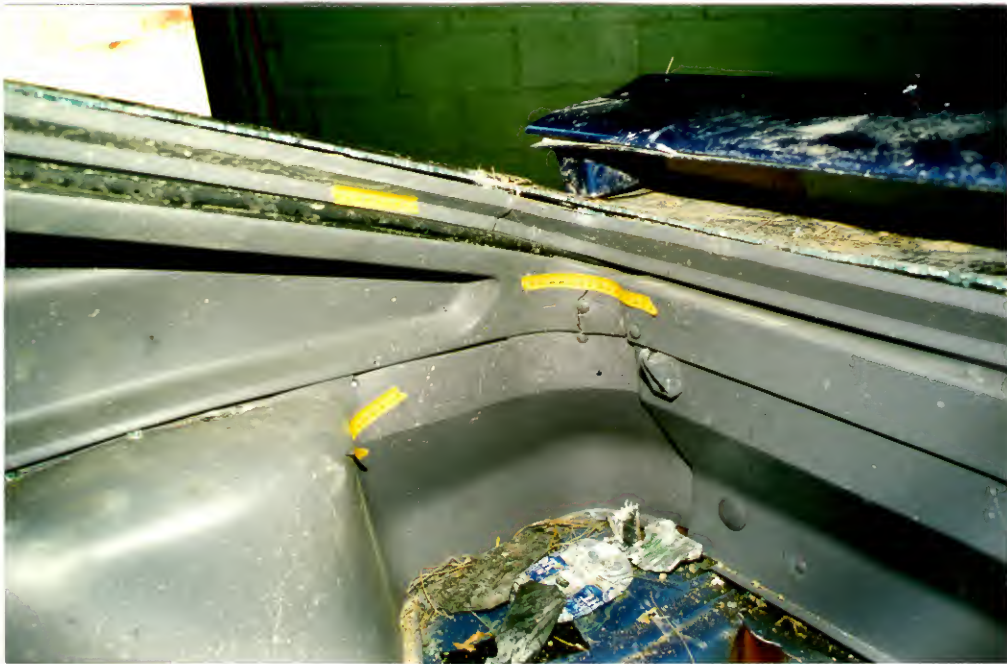
# 51 -- [REDACTED] 1993  
 [REDACTED] Illinois  
 TRC/IU: 93-07, Task: 0103  
 TRC Photo: driver contact  
 in right rear cargo area

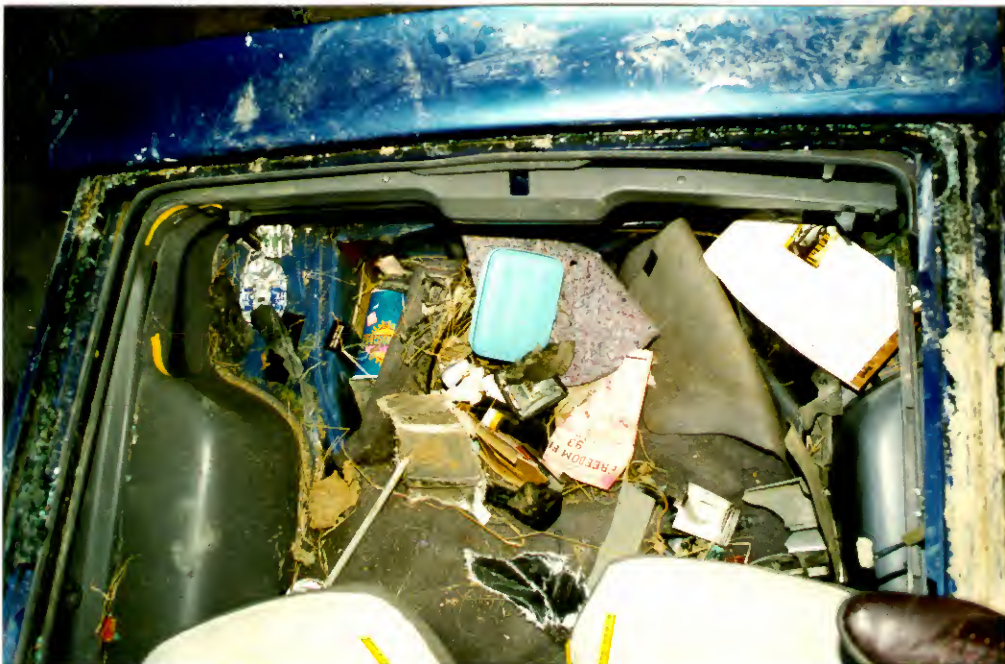
# 52 -- [REDACTED] 1993  
 [REDACTED] Illinois  
 TRC/IU: 93-07, Task: 0103  
 TRC Photo: driver contact  
 in RR cargo area from top
